Inspection Report

Mine Name: Lisbon Valley
Operator Name: Rio Algom

Permit number: M0370001
Inspection Date: June 14, 2006
Time: about 1:30-2:00 PM

M0370001, Lisbon Mine, Rio Algom

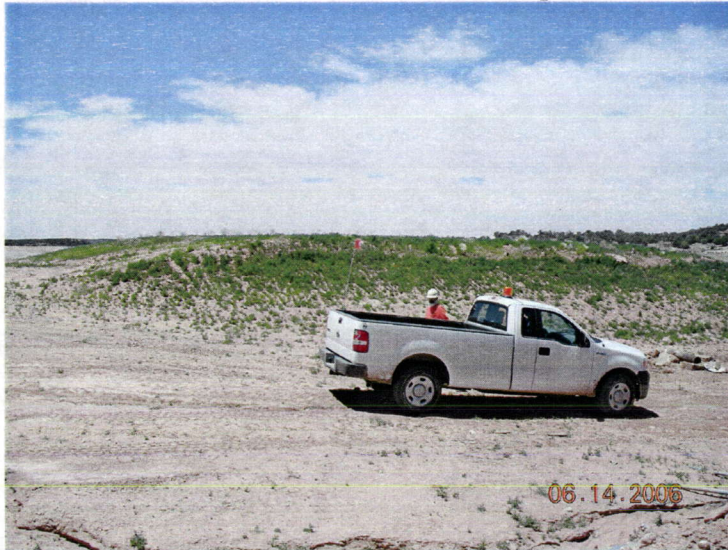
There are two shafts that are part of the permit with the Division, and both have been sealed. The production shaft (Photos 1 and 3) is 2350 feet deep and 18 feet in diameter, and the vent shaft (Photos 2 and 4) is 2650 feet deep and 18 feet in diameter.

The file contains conflicting information about when the shafts were sealed, but it appears to have happened sometime between 1990 and 2000. According to inspection reports in the file, I-beams were first placed in the shafts as the bases for the plugs. One and one-half inch rebar was then keyed into the shaft collars followed by pouring concrete caps three feet thick.

The production shaft (Photo 1) still needs some grading before it is seeded. Inspection reports indicate the ventilation shaft was seeded in the spring of 1996, but the vegetation does not match that in surrounding areas.

The operator needs to submit form MR-SITE applying for partial release of the reclamation surety. The Division could potentially release the portion of the surety being held for sealing the shafts, but some money needs to be held for revegetation of the shaft areas. The disturbed area contains 0.25 acres according to annual reports.
